MISCELLANEOUS PAPER S-73-55

CONDITION SURVEY, WRIGHT-PATTERSON AIR FORCE BASE, OHIO

R. D. Jackson

June 1973

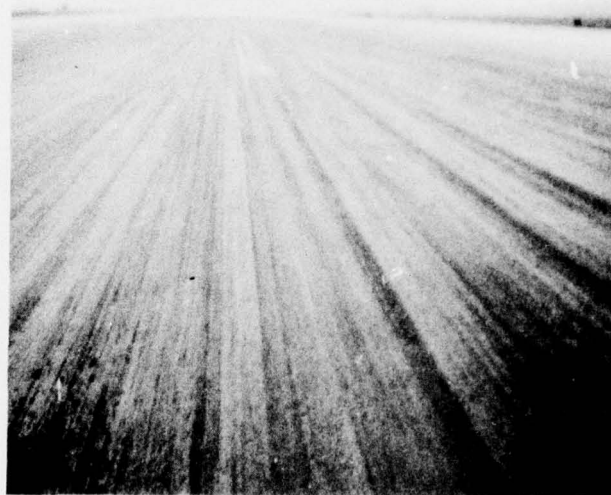
Photo 2. General view of TR overlay
near NE end of runway

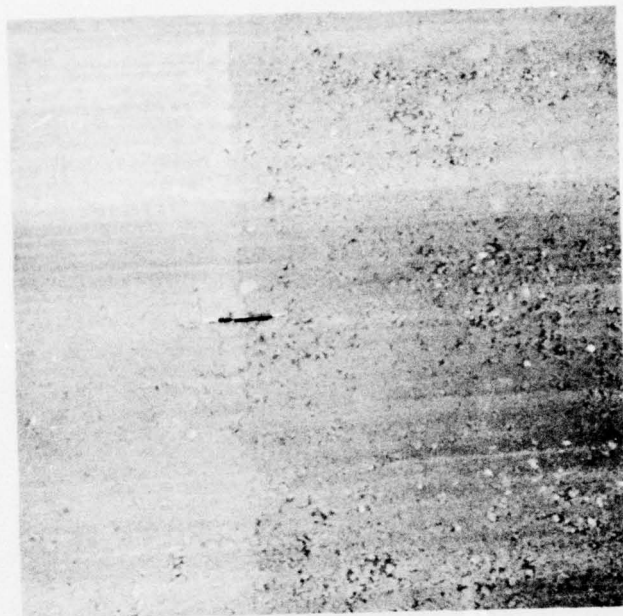
Photo 3. Closeup view of joint between
AC and TR overlays of runway

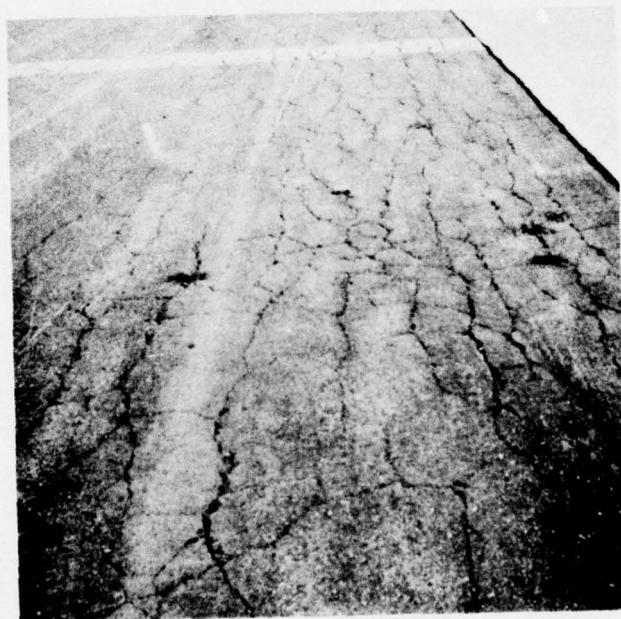
Photo 4. Poor condition of area of
shoulder pavement on taxiway 17

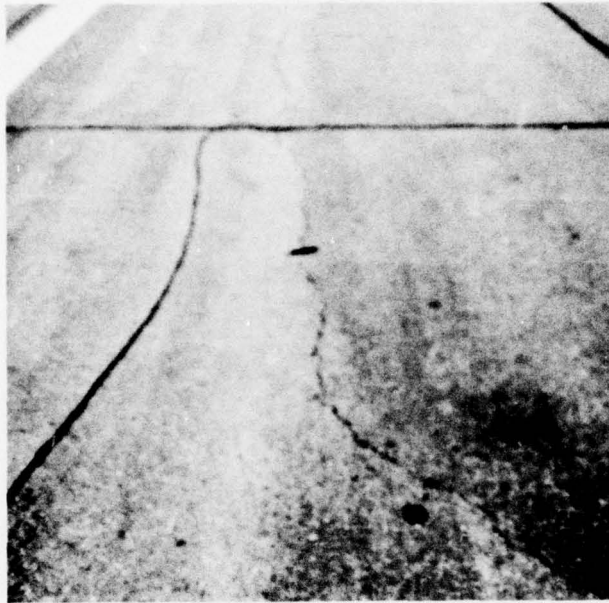
Photo 5. Reflection cracks in AC pavement of taxiway 1

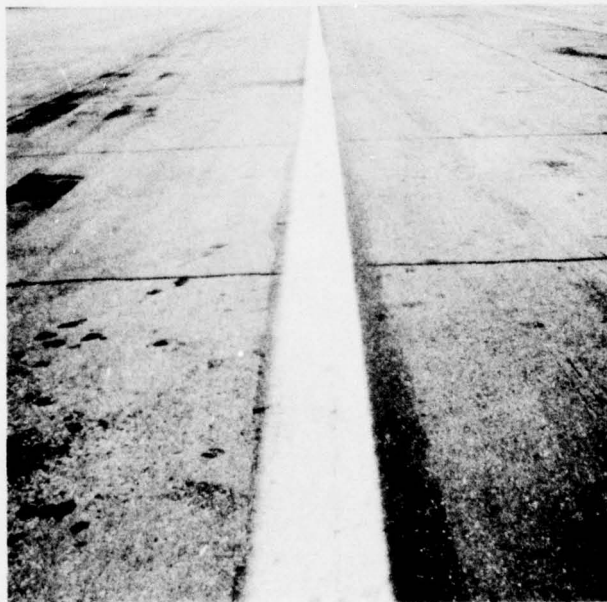
Photo 6. View of portion of taxiway 12 used primarily for parking

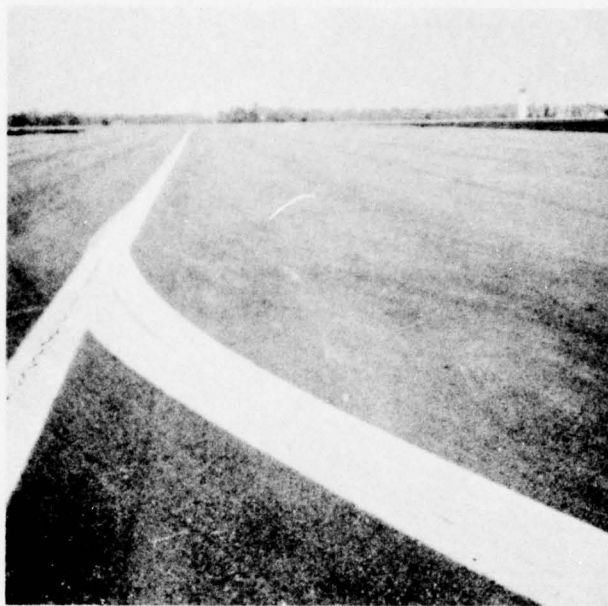
Photo 7. General view of taxiway 9

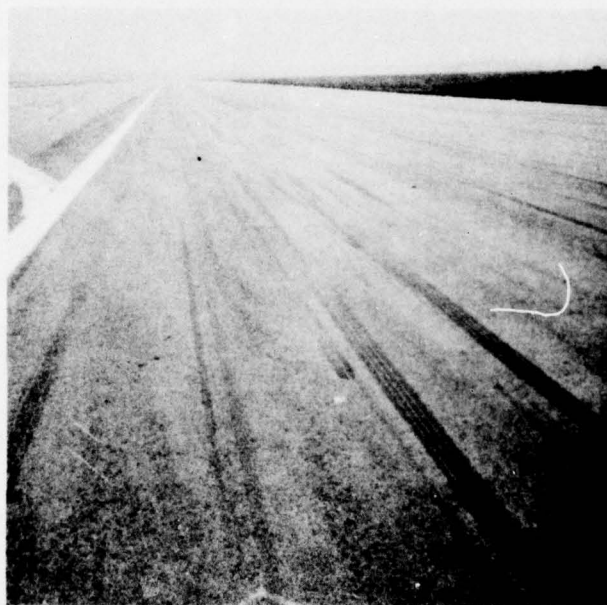
Photo 8. Good condition of taxiway 21 at intersection with taxiway 8

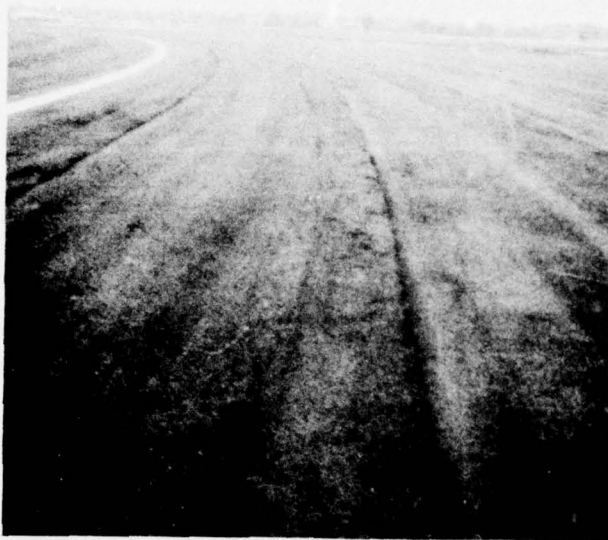
Photo 9. Paving lane joints in taxiway 10
and warm-up apron 1

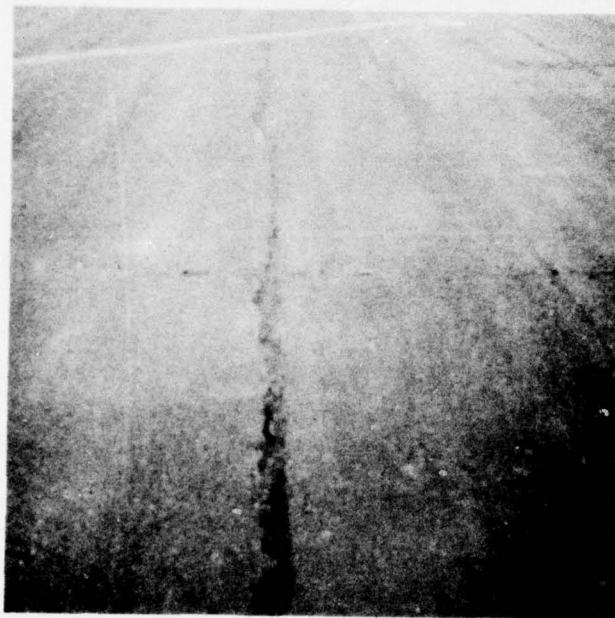
overlaid with TR or AC, except the alert hangar apron. The overlaid apron areas were in fair to very good condition. Photo 10 shows a general view of parking apron E, looking south from the base operations office. A view of parking aprons B and C is shown in photo 11. The alert hangar apron was in poor to failed condition. The SAC operational apron was in fair to good condition. The predominate major defect in this apron was longitudinal cracking, and corner spalls and pop-outs were also prevalent. Warm-up apron 2 was in excellent condition based on the percentage of slabs containing no major defects. The nose dock stubs were in conditions ranging from poor to very good.

Photo 11. General view of parking
aprons B and C
